Fiberglass Shingles

Shingle Splitting Problem Observed in a Number of Western Applications

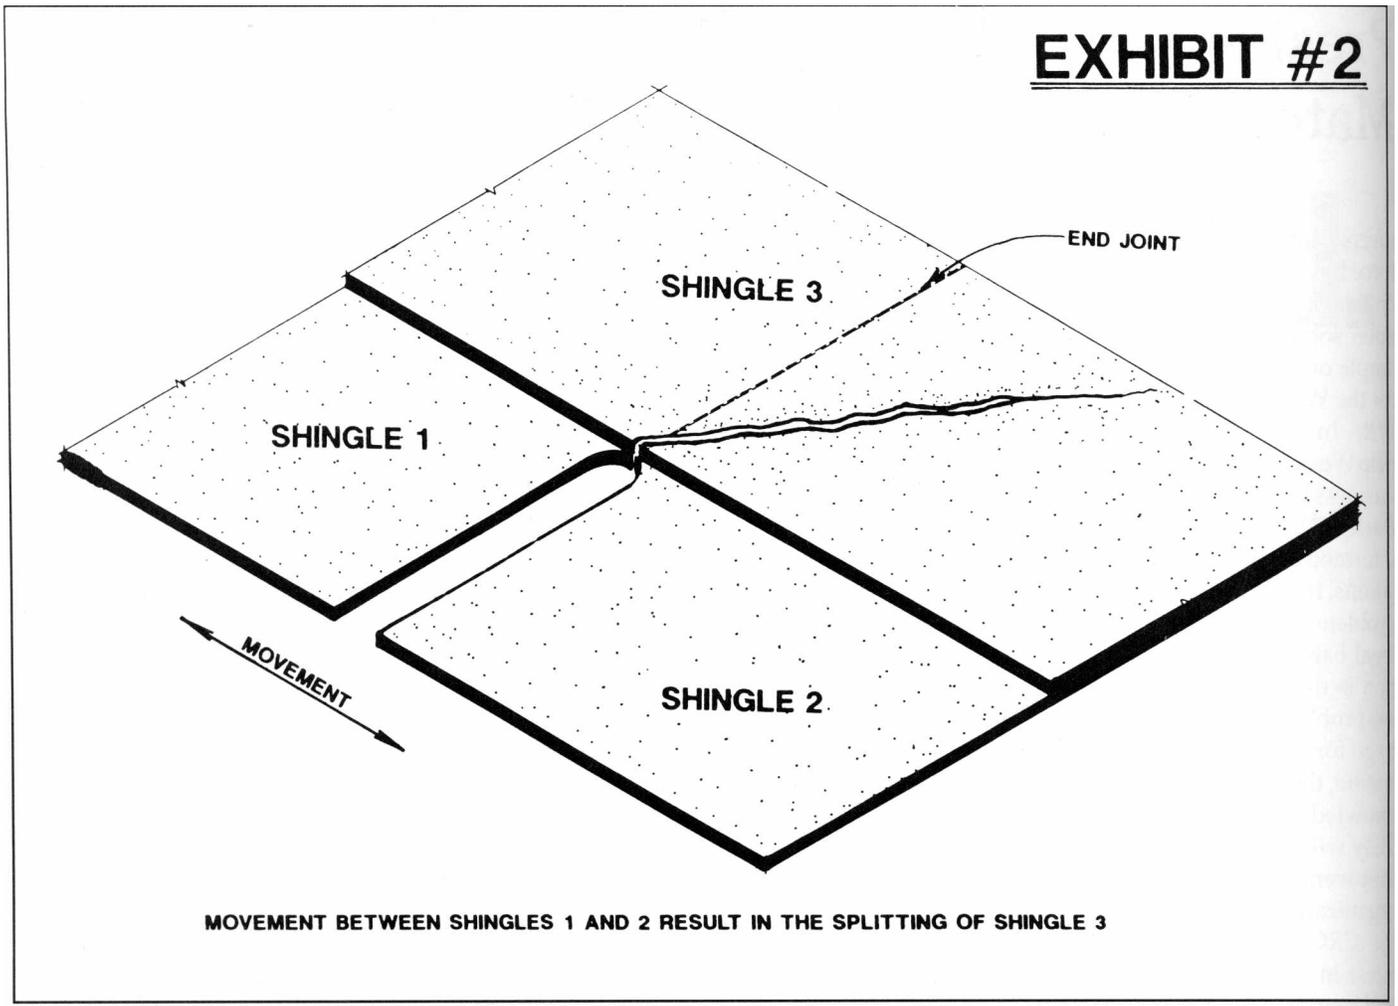
EXHIBIT #2

D 3018, Type I, and generally carry a UL Class A rating. These shingles have been splitting in the face of the shingle directly above the edge joint of the preceding shingle. The splitting problem in the fiberglass shingle appears to be independent of either substrate or fastener type.

The fiberglass shingles have a tendency to expand and contract with thermal changes along the longitudinal basis. As the shingle expands and contracts, a stress builds up in the face of the shingle directly over the end joints of the underlying shingle. This produces a split in the face of the three-tab shingle.

In examining many of these shingles, it has been observed that the splitting action begins predominantly in the southward and westward exposures of the building. If one examines these structures in the early morning hours when the roof is cool, these splits are very obvious, and tend to run in a diagonal fashion. As the roof warms

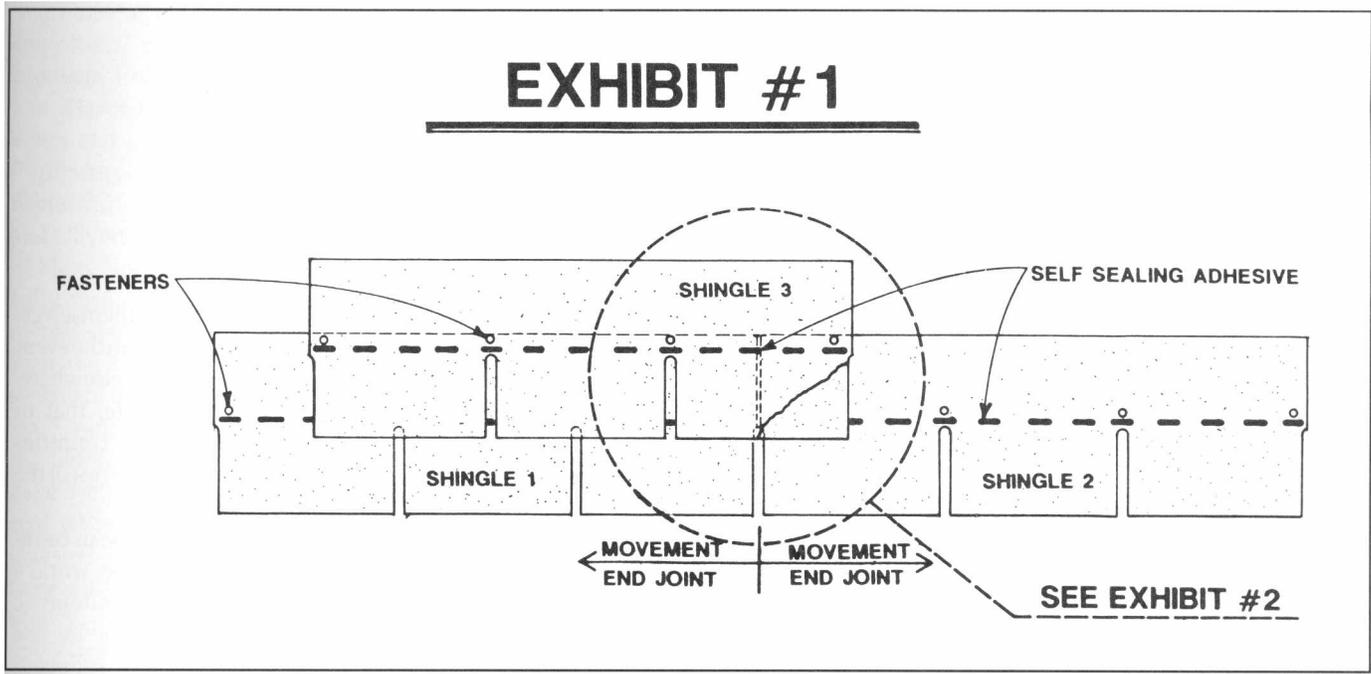
EXHIBIT #1

The failure mode is a combination of three factors: a lack of sufficient tensile strength in the fiberglass mat; thermal expansion and contraction of the shingles; and a full adhesion of the self-sealer strip over the end joints. From a tensile strength standpoint, it has been observed that in some cases, when an individual shingle is picked up and held vertically, it will tear under its own weight. In performing a tensile strength test, it

has been observed that shingles with the greatest tear tendency have a tensile strength below 60 pounds per inch at the time of failure.

At the present time, the bulk of these shingles fall under ASTM D 3018-79 Type 1. There is not a clear-cut industry standard for tensile strength or the quantity or spacing of self-sealer adhesive. Areas such as a minimum tensile strength, adhesive spacing, and quantity should be addressed by the industry.
