## Aging and Hail Research of PVC Membranes

Frank J. Foley, Jim D. Koontz and Joseph K. Valaitis

**Key Words:** Membrane, roof, plasticizer, hail, PVC.

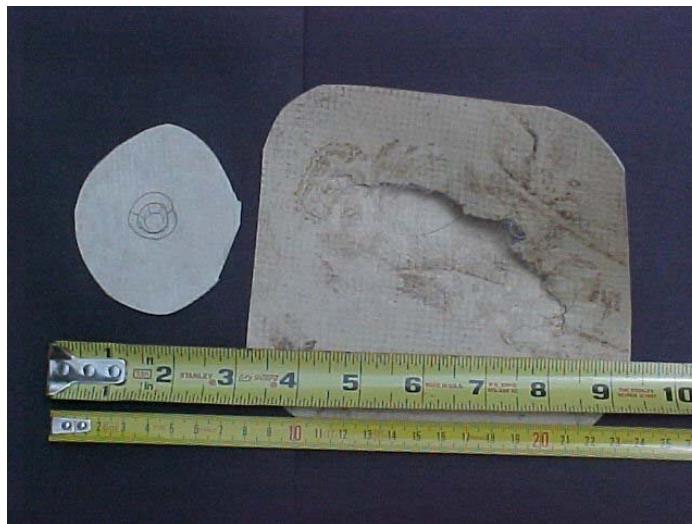
***Photo 1: Small and large hail damage to two distinct PVC roof membranes***

*Photo 1* presents two samples of impact fracture on PVC roof membranes, both from hail. One is small hail damage taken from a roof in Conroe, Texas where the membrane was 18 months old. The other sample is of large hail damage taken from a roof in Fort Worth, Texas where the roof membrane had 42 months in exposure. The characteristic fracturing of the small hail sample in the photo is a series of concentric rings of fracture. This fracturing will also occur when a large and heavy object such as a large screwdriver is dropped onto an embrittled, membrane surface.

But what is the action of impact fracture? Impact fractures from hailstones are usually concentric arches of fractures (*Photo 1*). It is proposed that the failure mode at impact is about membrane distortion as opposed to an instantaneous surface shatter. A close-up view and slow-motion impact would reveal fractures not in a single moment of contact but rather in a timed sequence of elongation and subsequent fractures. As the projectile drives deeper additional distortion would create additional, outer rings of fractures. In this view, what role would reinforcement play in the prevention of fracture failure? It is conjectured that the reinforcement would provide a limit to distortion. The stronger and tighter the fabric weave, the more limited the distortion.

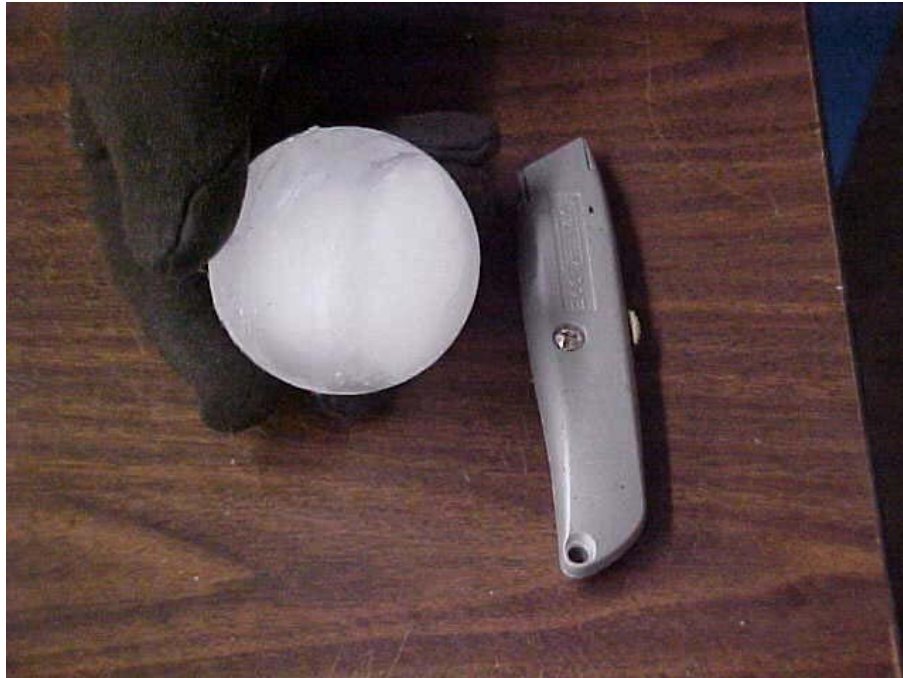
**Photo 2: Sphere of frozen ice for impact testing**

Spheres of frozen water were used as projectiles for impact testing against the large membrane samples. The ice sphere test method was selected since laboratory cast ice spheres closely correlate with hail. Prior studies have shown that approximately 75-percent of large-sized hail is spherical or nearly spherical in shape.<sup>6</sup> Hail density ranges have been reported between 0.02 lb/inch<sup>3</sup> and 0.03 lb/inch<sup>3</sup> (0.7 and 0.91 gm/cm<sup>3</sup>) the latter value being the density of pure ice. The ice spheres used in this research were cast pure ice (*Photo 2*).

Vickie Crenshaw and Jim Koontz defined this test protocol of constructing ice spheres in earlier simulated hail research of various roof coverings.<sup>7</sup> Constructing the simulated hailstones in silicon molds in two stages permitted the expansion of ice without cracking. Weighing the mass of water into each mold provided consistency of sphere masses and diameters. Ice spheres were formed at 10<sup>0</sup> F (-12.2<sup>0</sup> C).
