# **Simulated Hail Damage and Impact Resistance Test Procedures For Roof Coverings and Membranes**

By Vickie Crenshaw and Jim D. Koontz, P.E.,

Article based on presentation at Roofing Industry Committee On Weather Issues Meeting, Dallas, Texas  
October 27, 2000

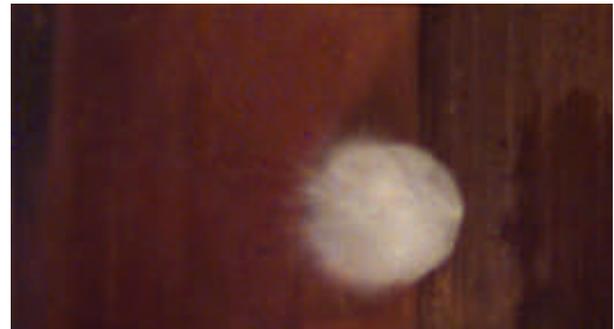
The answer to the technical question of why some roofing systems fail when impacted with steel versus ice is relatively simple. The ice spheres will compress or crush upon impact with a very hard surface such as concrete tile. Figure B depicts an ice sphere at the moment of impact with a concrete tile. A slight crushing of the ice is seen to occur at the surface of the sphere.

*Figure B. Ice Sphere at Moment of Impact with Concrete Tile.*

Both projectiles, the ice and steel, struck the concrete tiles with the same impact energy. Therefore the impact failure with steel does not accurately reflect the tile roofing products true hail resistance.

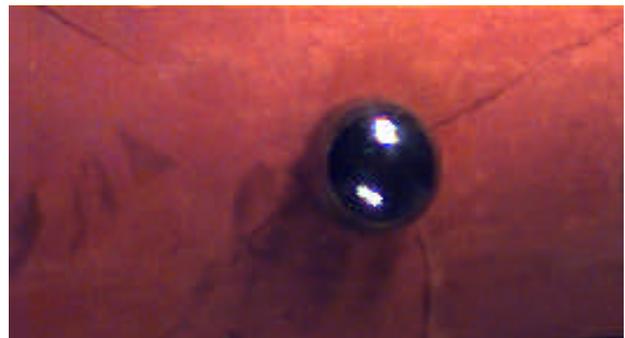
When steel projectiles are used, however, the fact that the steel is much harder than the concrete and does not compress can result in a tile failure. The moment of impact of a steel projectile upon a concrete tile is captured in Figure C.

*Figure C. Steel Projectile at Moment of Impact with Concrete Tile.*
